Investigation of Premature Failure of Brass Tubes Leaking in a Heat Exchanger

Usman Niaz¹, Mihaiela Minea Isac² and Roderick I L Guthrie^{1,2*}

Failure investigation of a typical heat exchanger was conducted. The equipment comprised brass tubes (C23000) fitted with an AISI 1020 “turbulator spring” at its center. The heat exchanger developed water leaks during service. Ideally, the heat exchanger has a recommended life of 40,000 hours, but the one in question only lasted 12,000 hours. Treated water at an operating pressure of 64 psi. was circulated through the brass tubes with inlet and outlet temperatures of 47 °C and 57 °C, respectively. On the external surfaces of the tubes, an air/fuel mixture entered the heat exchanger, at a temperature of 75 °C, and left at 52 °C. As such, the heat exchanger was designed to lower the air/fuel mixture’s temperature by 20 °C, before the gaseous mixture entered an engine, for optimum combustion conditions. Scanning Electron Microscope (SEM) and Energy Dispersive Spectroscopic (EDS) analysis revealed that the surface areas of tubes suffering from corrosion, being depleted in zinc versus the bulk zinc content of the alloy; an indication of dezinc

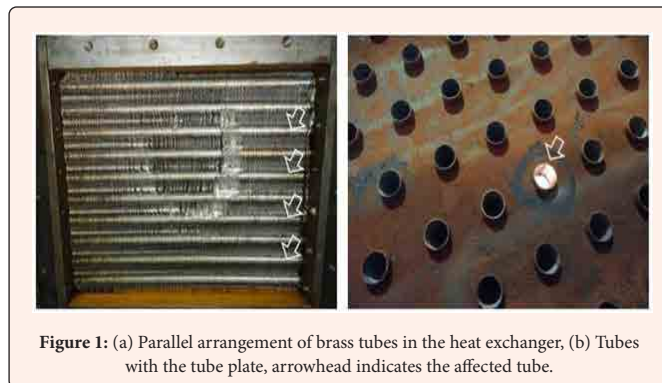
Figure 1: (a) Parallel arrangement of brass tubes in the heat exchanger, (b) Tubes with the tube plate, arrowhead indicates the affected tube.

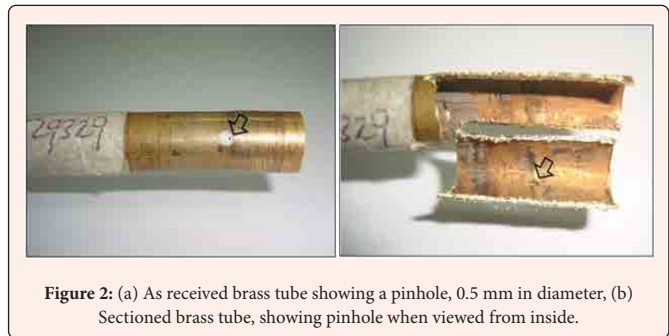
Visual examination of one of the failed brass tubes was performed. This revealed a small pinhole on its surface, approximately 12 mm from the edge, as shown in Figures 2a & 2b. The size of the pinholes was approximately 0.5 mm in diameter. The adjacent areas of the tubes, around the pinholes, were observed to be bulged out, maybe due to the overpressure of water flowing through the tube (thermomechanical damage). No apparent surface defects were observed. However, when a similar pinhole, was analyzed from the inside of the tube, it appeared to be an irregular-shaped pit, length 1.2 mm and depth 0.7 mm., as shown in Figure 3. To investigate further, the brass tube was sectioned/flattened as shown in Figure 4 and analyzed under a stereomicroscope. Continuous pits/cavities were observed, specifically in those regions where the turbulator spring had been contacting the brass tube. These pits/cavities could have resulted from the erosion-corrosion phenomenon i.e. galvanic induced corrosion due to the two different materials, contacting each other (brass tube and turbulator spring), coupled with an erosion of the brass tube by the cyclic vibrations of the turbulator spring under operation, as shown in Figure 4. The distance between two consecutive pits/cavities equals the distance between two consecutive coils of the turbulator spring i.e. 7.5mm, running through the length of the brass tube, as shown in Figure 4. The hardness of the brass tube and turbulator spring is given in Table 2.

Figure 2: (a) As received brass tube showing a pinhole, 0.5 mm in diameter, (b) Sectioned brass tube, showing pinhole when viewed from inside.

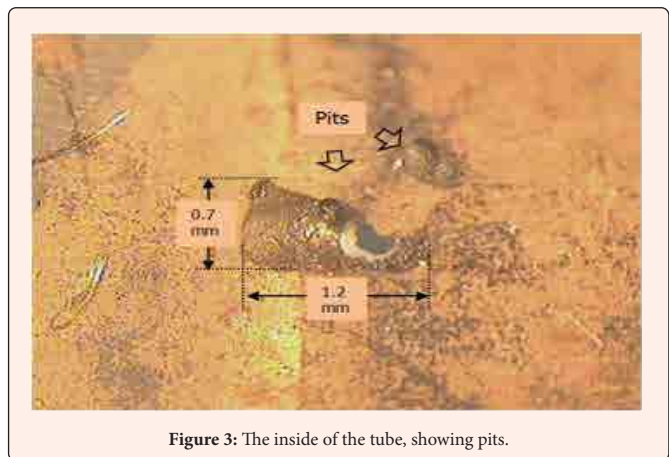
Figure 3: The inside of the tube, showing pits.

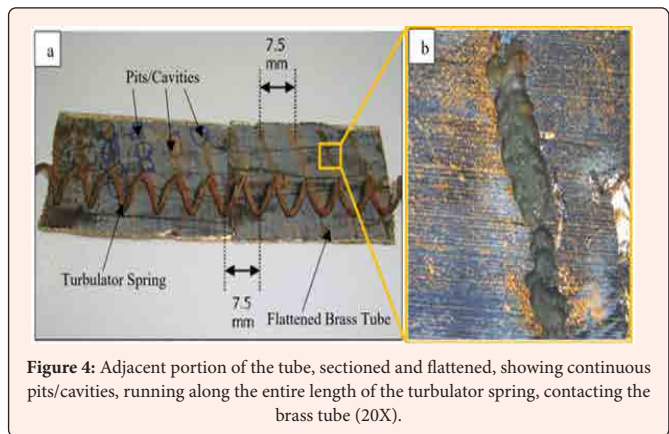
Figure 4: Adjacent portion of the tube, sectioned and flattened, showing continuous pits/cavities, running along the entire length of the turbulator spring, contacting the brass tube (20X).

Continuous pits/cavities were observed, specifically in those regions where the turbulator spring was in contact with the brass tube. These pits/cavities could have been the result of erosion-corrosion phenomena i.e. galvanically-induced corrosion due to the two different materials, contacting each other (brass tube and AISI 1020 turbulator spring). This was coupled with an erosion of the brass tube as a result of cyclic contact of the harder turbulator spring (500 HV) with the soft tube (92 HV), i.e. in-service damage. Thermo-mechanical expansion of the tube resulted from the combined effect of the pressure build-up on the wall of the brass tube and to the temperature of the fast-flowing water, contributed to the failure, as well. Scanning Electron Microscope (SEM) and Energy Dispersive Spectroscopic (EDS) analysis indicated that the areas that suffered corrosion attack were depleted in zinc, in comparison to the bulk of the alloy.

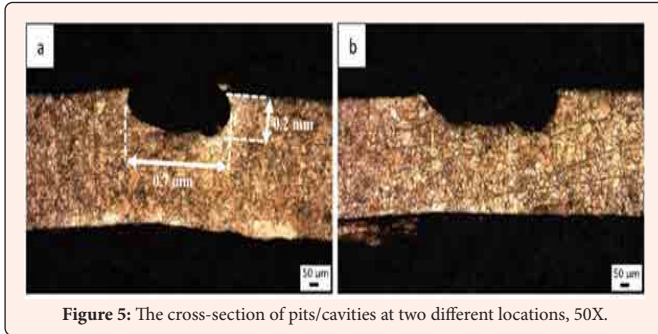
Metallographic examination was carried out to study the morphology and extent of the pits/cavities. These measured 0.2 mm deep and 0.7 mm wide, as shown in Figure 5. This corresponds to a loss of approximately 33% of the initial thickness of the tube i.e. ~0.6 mm. Concerning the grain structure of the material, the damage is smooth and trans-granular. The grain structure of the base tube is homogeneous as shown in Figure 5.

Figure 5: The cross-section of pits/cavities at two different locations, 50X.

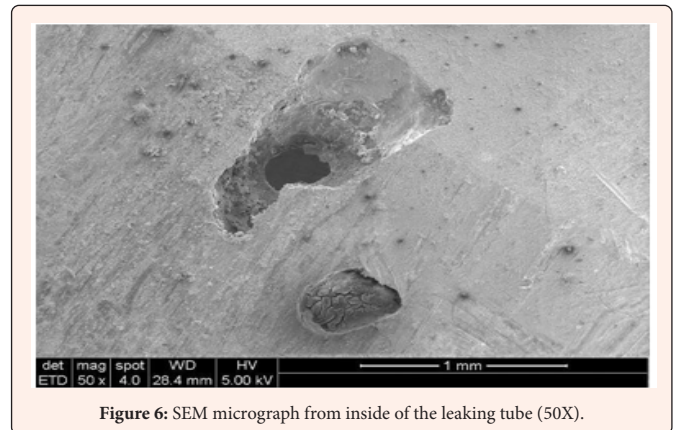
The brass tube was sectioned and analyzed using a Scanning Electron Microscope (SEM) (Figures 6 & 7). Additionally, Energy Dispersive Spectrometry (EDS) analysis was also carried out at various locations within the tube, as shown in Figures 8 & 9. As per the EDX analysis, Cu and Zn were identified as the principal alloying elements, in accord with the wet chemical analysis results presented above. Additionally, the pitted surface was observed to be depleted in zinc (de-zincification). Apart from the de-zincification of brass, traces of Ca, Fe, S, and P, were also observed to be deposited within these pits/cavities, as shown in Figure 8. Wet chemical analysis results (Table 3) have confirmed that these elements/compounds were present in the water, circulating through the brass tubes, and had accumulated over time. It is still unclear as to what extent they might affect the useful life of the heat exchanger, but they could have played a positive role in increasing the corrosion rate of the brass tube.

Figure 6: SEM micrograph from inside of the leaking tube (50X).

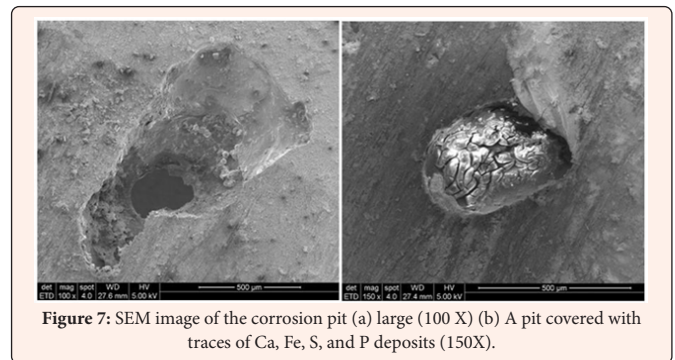
Figure 7: SEM image of the corrosion pit (a) large (100 X) (b) A pit covered with traces of Ca, Fe, S, and P deposits (150X).

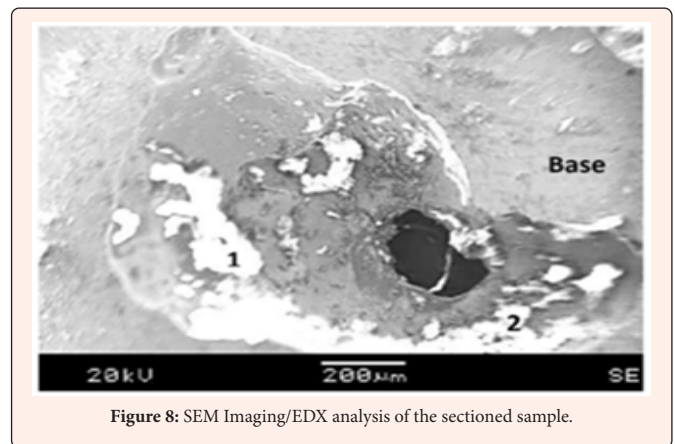
Figure 8: SEM Imaging/EDX analysis of the sectioned sample.

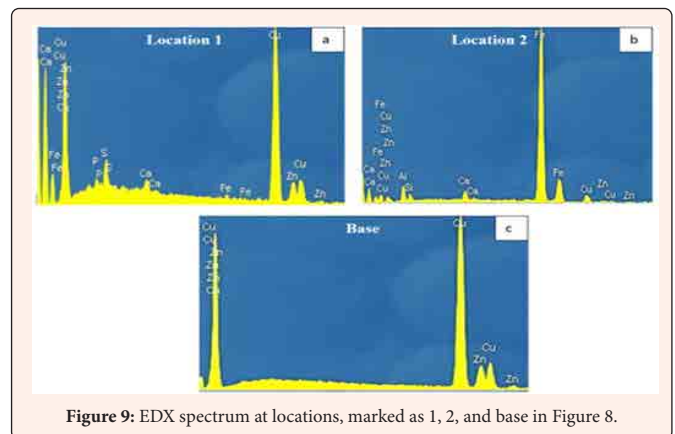
Figure 9: EDX spectrum at locations, marked as 1, 2, and base in Figure 8.
