Current Trends in Engineering Science (CTES)

On the Mechanical and Metallurgical Causes of an Ultralight Aircraft in-Flight Crash

Abstract

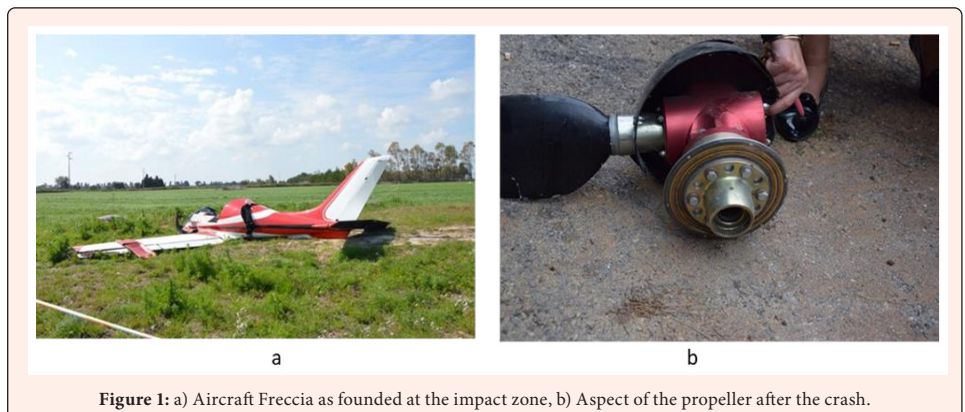
Figure 1: a) Aircraft Freccia as founded at the impact zone, b) Aspect of the propeller after the crash.

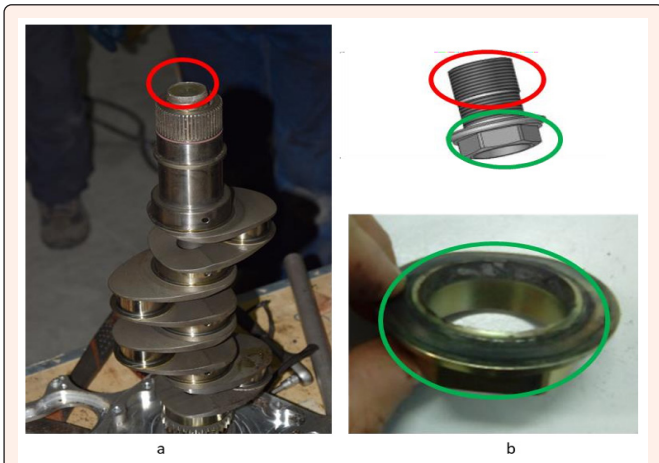
Because of the failure, the central bolt body was found screwed to the shaft (Figure 3a), while the hexagonal head was retained by the propeller flange (Figure 3b).

Figure 3: Fracture surface of the central bolt: a) shaft side; b) propeller side.

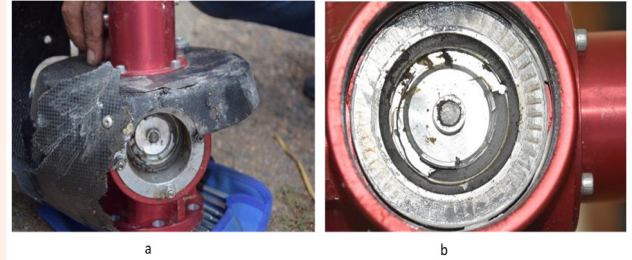
The other relevant failure is located between the blade and the propeller. The blade ends with a screw socket that allows the connection with the blade propeller through an axial bearing. In this case the fracture surface involves different components, including the mechanism used for the tilt regulation of the blade, which is not relevant from a structural point of view (Figure 4).

Figure 4: Aspect of the zone of the defective blade: a) as founded; b) after bearing removal.

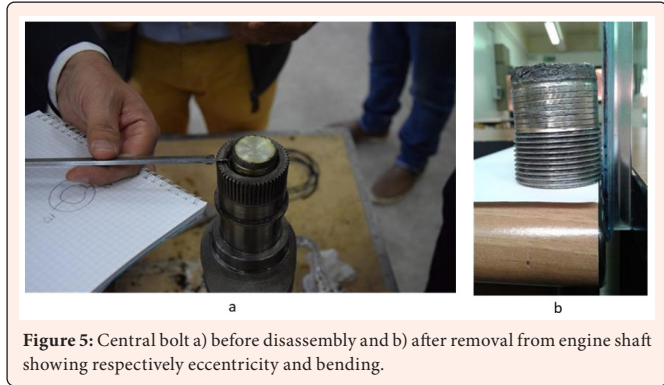
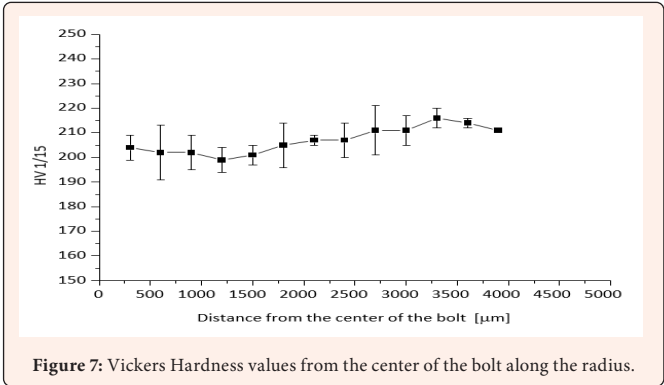
circularly cut around the bolt facilitating its unscrewing. The central bolt is not rectilinear and appeared already permanently deformed before disassembly (Figure 5a), since it has been interested by a relevant plastic bending deformation before failure (Figure 5b). A sample of the base material to be used for metallographic analysis has been obtained from the central zone comprised between the fracture surface and the threaded connection.

The bolt failure was clearly originated by a static bending overload [17-18], as showed by the permanent deformation of the bolt, by the different macroscopic aspects of the diametrically opposite compressive and tensile zones, and by the mixed ductile/brittle fracture as generally happens in zone of severe stress concentration, corresponding to the sharp notch between bolt and hexagonal head.

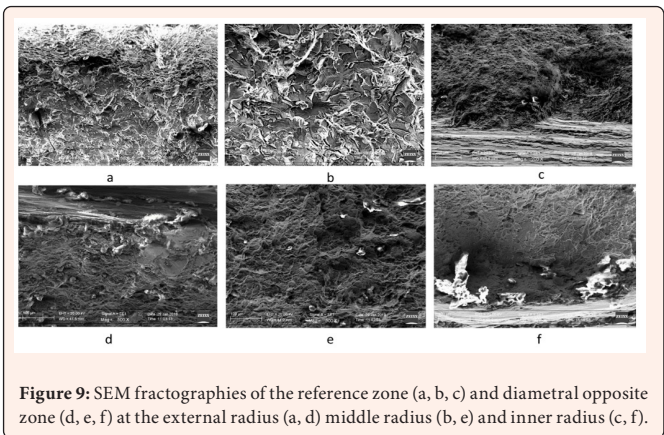
Referring to the same regions in figure 8a, the fracture surfaces at the inner, medium, and external radius along the thickness have been analyzed by SEM (Figure 9). The fractures result mixed with both brittle and dimples areas. In particular, the absence of fatigue crack propagation regions on the fracture surface and the macroscopic plastic bending of the bolt (Figure 6) gives the indication that the failure was determined by a bending static overload [17-18,20-21], which determined firstly a plasticization of wide volume of material and finally the static failure.

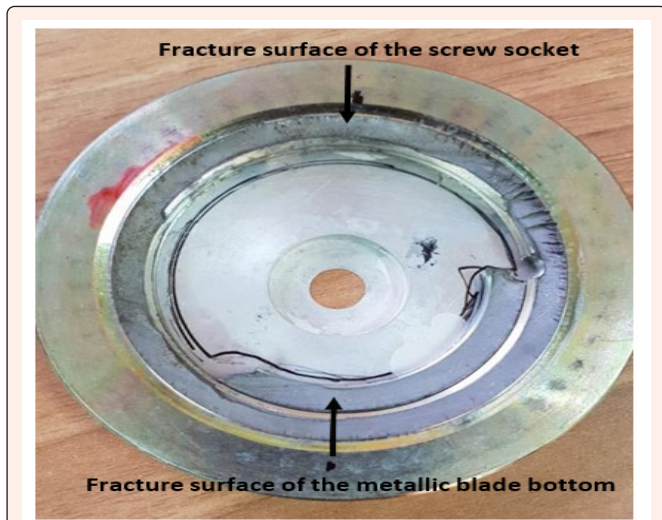
After disassembling of the screwing holding of the broken blade (Figure 10), failure analysis has been concentrated on the screw socket and on the small part of blade end that has been retained by screw during failure (the part of the inner ring in figure 10). The original geometry of the socket is shown figure 11. All these components are made of 39NiCrMo3 steel and are mounted together using the M52x2 screw. Failure occurred in correspondence of the notch between the two cylindrical features having diameters of 60 and 82mm. In figure 11 the notch is characterized by a tip radius of 1mm.

Figure 10: Fracture surface of the screw socket (external zone) and of the part of blade bottom that has been retained by screw during failure (inner zone).

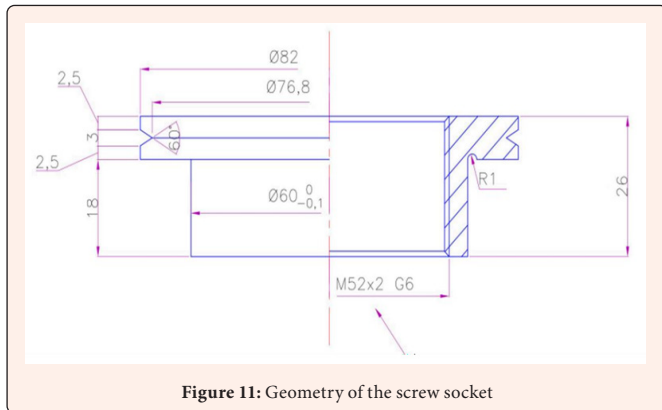
Figure 11: Geometry of the screw socket

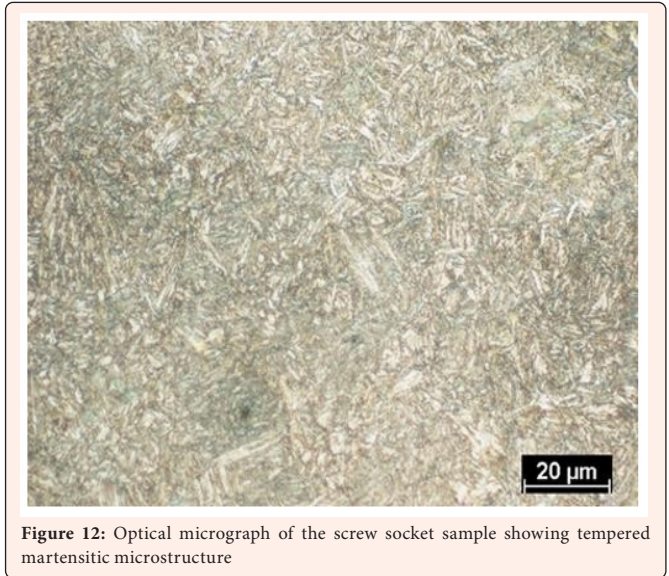
The microstructure of the screw socket sample after metallographic preparation and the Nital chemical attack exhibits tempered martensite (Figure 12). Nickel, in combination with Chromium, improves the hardenability delaying both the austenite to perlite and austenite to bainite transformations. So, oil quenching is employed to produce a martensitic structure from austenitizing temperature (850°C) [3-5]. The further addition of 0.2% Mo increases still more hardenability and minimizes the susceptibility to embrittlement during the tempering step. The average value of Vickers hardness measurements was found equal to 304±3. Microstructural features and hardness are compatible with those of a 39NiCrMo3 oil quenched and tempered at 650°C [3,4].

Figure 12: Optical micrograph of the screw socket sample showing tempered martensitic microstructure

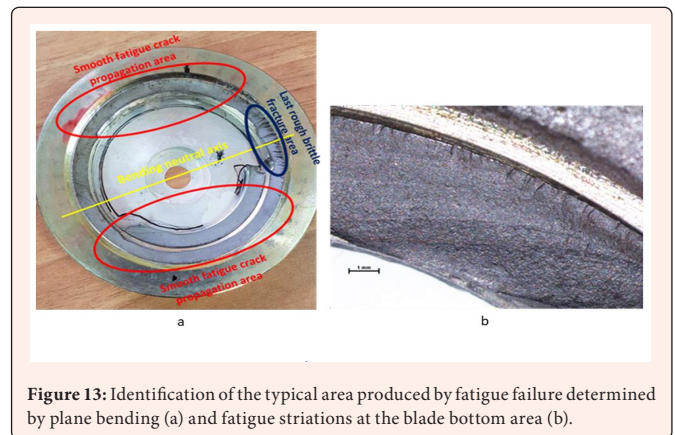
The surface failure of the screw socket is a classic fatigue failure determined by alternating plane bending [16-17, 20-21]. Fatigue cracks initiated in correspondence of opposite region of the fillet radius of the notch and propagated for a wide extension in the screw socket. Starting from several initiation points located on the external radius and in opposite regions with respect to the neutral axis of the bending load, cracks propagate firstly radially towards the centre of the socket and then circumferentially, as highlighted in figure 13. This is particular evident at the blade bottom (inner area in figure 10 & 13a), where it is possible to identify the classical fatigue striations perpendicular to the crack propagation front (Figure 13b). So, that propagation passed through the screw and also interested the blade bottom. At the moment of the final failure, the partial zone of the blade end was retained by the screwing and it has been found attached to the failed socket. The two propagating zones are symmetrically disposed about the ideal axis reported in yellow (Figure 13a), which represents approximately the neutral axis of the fatigue bending loads. The region around the neutral axis in the blue circle of figure 13a corresponds to the brittle final failure due to the insufficient section needed to hold the centrifugal load.

Figure 13: Identification of the typical area produced by fatigue failure determined by plane bending (a) and fatigue striations at the blade bottom area (b).

So, according to the previous analysis, the failure was determined by a bending plane fatigue loading that has been enhanced by the stress concentration at the notch tip present in the screw socket. Crack initiated at the notch and rapidly propagated firstly radially and then circumferentially up to the section had become insufficient to hold the tensile centrifugal load, determining the final brittle failure of the screw socket (blue circle in figure 13a), and the loss of the blade.

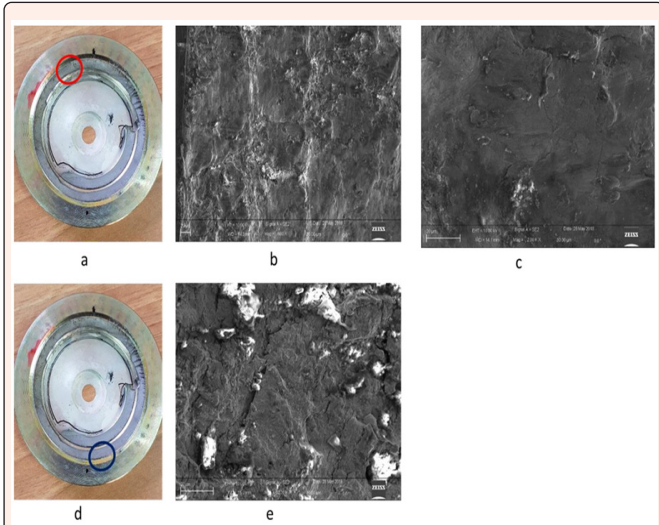
Many regions of fatigue striations have been recognized (Figure 14b) through a SEM analysis of the fracture zone highlights by the red circle of figure 14a. At higher magnification (Figure 14c), the surface between striations appears smoothed as expected in regions where fatigue propagation has occurred. Moreover, in the opposite side of the fracture surface, highlighted with blue circle (Figure 14d), a relevant number of microcracks, characteristic of the fatigue initiation phase, has been observed (Figure 14e).

Figure 14: SEM analysis of the fracture surface highlight in the red circle (a) exhibiting fatigue striation observed at different magnification: 500X (b) and 2000X (c). In the blue circle (d) fracture surface exhibits fatigue striations together with microcrack (e).

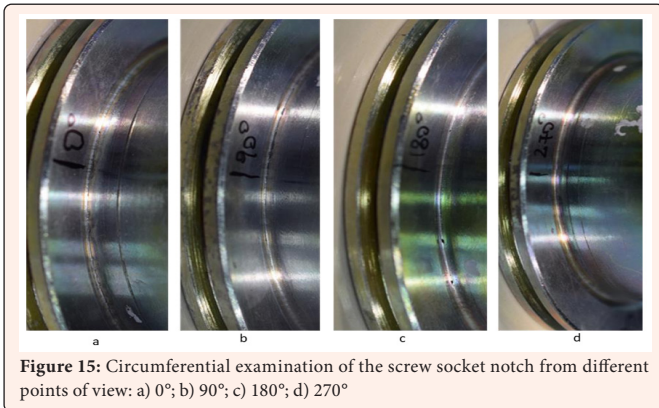
The visual examination of the notch in the screw socket of the unbroken blade showed unequivocally the presence of an extended circumferential crack. The circumferential crack has been shown in figure 15, as a sequence of pictures taken in correspondence of the four quadrants, in which has been ideally divided the circumferential notch. Fixing an arbitrary direction as 0°, corresponding to the localization of the cord of the blade profile, the crack seems particularly marked in the quadrants comprises between 0°-90° and 180°-270°, while crack is absent between 90°-135° and 270°-315°. The localization of the cracks is coherent with the localization of the nucleation and propagation zones of the fracture surface of figures 13 & 14. The previous features can be better observed by stereomicroscope analysis (Figure 16). The entity of the notch crack precludes to an imminent final failure. So, the process failure of the second blade has been interrupted just by the failure of the first one.

Figure 15: Circumferential examination of the screw socket notch from different points of view: a) 0°; b) 90°; c) 180°; d) 270°

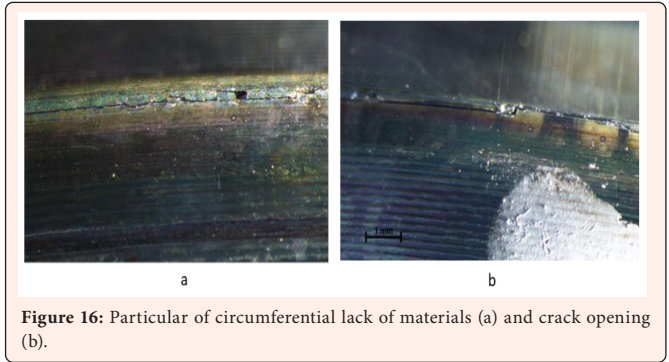
Figure 16: Particular of circumferential lack of materials (a) and crack opening (b).

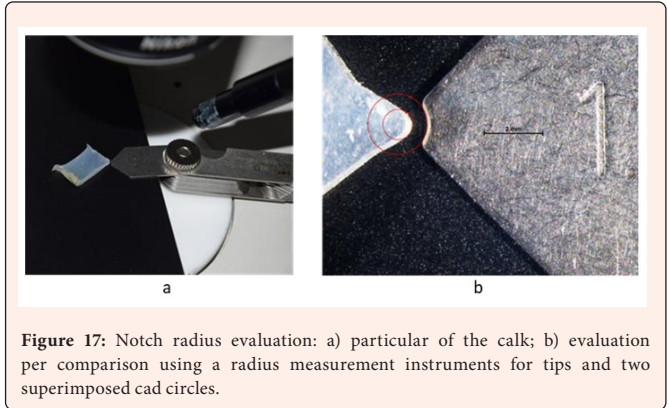
The measurement of the radius of the notch has been carried out on the unbroken blade by making a calk of the notch in silicon past (Figure 17a). A representative section of the notch section was therefore obtained and compared with a radius measurement instrument for tips (Figure 17b). As evident, the geometry of the notch is deeply different from the nominal one reported in figure 11 and equal to 1mm. Moreover, the silicon calk has also detected the presence of a significant undercut surface that reduces the net section of the screw socket (Figure 17b). Finally, the notch radius was proven to be equal to 0.5mm by drawing the two red circles in figure 17b having a radius of 0.5 and 1mm, respectively. The stress concentration due to the actual value of notch radius has been analysed by a FEM model based on Code Aster software and compared with the nominal one.

Figure 17: Notch radius evaluation: a) particular of the calk; b) evaluation per comparison using a radius measurement instruments for tips and two superimposed cad circles.

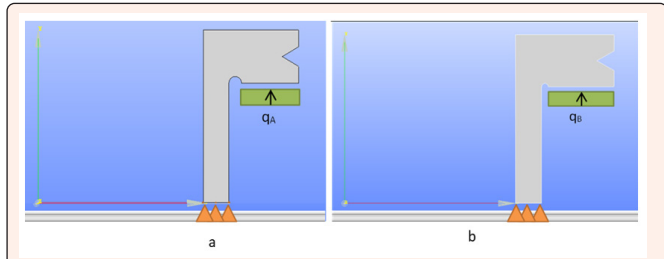
Since the aim is to evaluate the increase of the stress concentration due to the reduction of the notch tip, a simple axial load was considered. Assuming this condition, it is possible to exploit the axial symmetry of the component and of the applied load to build a FEM model using triangular plane elements with a linear formulation and axial symmetry option. Material has been assumed as linear elastic. Model A (notch radius of 1mm) and Model B (notch radius of 0.5mm) are shown in figure 18. The same figure reported the loading condition that was applied: the bottom of the component model was fixed in the vertical direction and a uniform load was applied on the annulus of the screw socket. It is worth to note that, by neglecting the presence of the undercut highlighted by silicon calk, the effective stress concentration at the notch tip results underestimated.

Figure 18: Geometry and load condition of the FEM models for a) Model A notch radius $r = 1\text{mm}$ and b) Model B notch radius $r = 0,5\text{ mm}$.

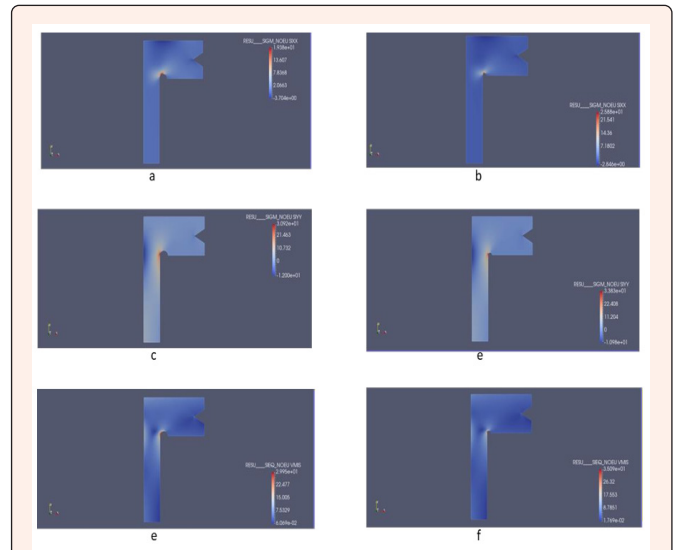
The FEM results showed that the stress state at the notch radius is characterized by relevant stress both in radial and axial direction. The radial stress (SXX), axial stress (SYX) and the Von Mises equivalent stress (SVM) are shown and compared in figure 19. The peak stresses are resumed in table 1, in which also the percentage increase of the stress component of model B with respect to the model A is reported.

As showed by results in table 1, all the stress component increased in model B. Particularly, radial stress suffers an increase of 33% of the stress concentration. That increasing in the notch stress concentration (33% in table 1) is very significant although it has been underestimated by having neglected the presence of the undercut. Therefore, the smaller value of the notch radius equal to 0,5mm has to be responsible for the fatigue failure of the screw socket.

Figure 19: Comparison of the stress state for Model A notch radius $r = 1\text{ mm}$ (a, c, e) and Model B notch radius $r = 0,5\text{ mm}$ (b, d, f): Radial stress S_{XX} (a, b), axial stress S_{VY} (c, d), equivalent Von Mises stress S_{VM} (e, f).
